# Risk Analysis Report

## Pluspetrol Peru Norte

Block 8, Peru

BakerRisk Project No.  
01-01943-013-19

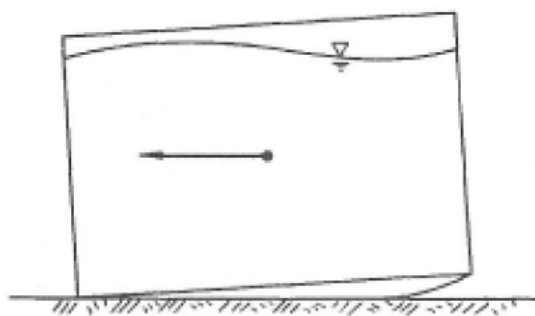
The damage at Pluspetrol facilities were mostly minor. The earthquake caused damage to the steel flanges of the hydrocarbon tank bases, as well as cracks on the concrete foundation ring. The major

damage was a leak from one of the 19 affected tanks.

The effects on a tank from an earthquake produces movement of the stored fluids that generate diverse base stress and deformations (see illustration in Figure 5). Such stress may generate damage to the tank depending on the conditions of the tank material before the earthquake. Concrete rings that form part of the tank foundation are also subject to earthquake damage by crushing from falling debris.

The repair procedure for the tank base metallic plate required removal of the floor plate, elimination and replacement of granular material, and installation of new floor plate. The work included testing both prior to the repair and afterwards.

Pluspetrol indicated that this type of failure on the tank base could also have occurred in the other 18 tanks to a lesser degree. Under the worst scenario, the other tanks could have minor leaks that will be detected over time and would require repair. Because of this, Pluspetrol will schedule the inspection of the 18 tanks to determine their interior condition.

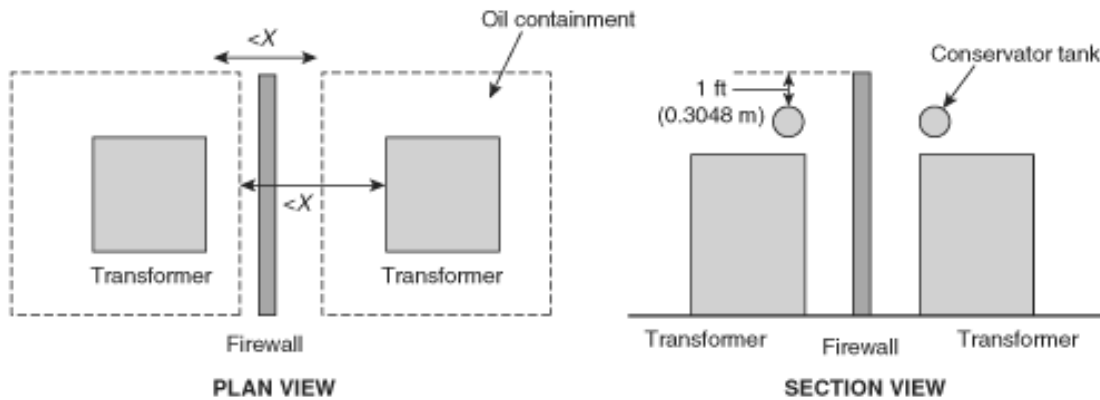
The firewalls for the transformers throughout the Block 8 Operations should be extended to at least 1 foot (0.31 meters) above the top of the transformer casing and oil conservator tank and at least 2 feet (0.61 meters) beyond the width of the transformer and cooling radiators as indicated in Figure 5 below.

**BakerRisk Comment:** *No progress on completing this recommendation.*
