# Risk Analysis Report

## Pluspetrol Peru Norte

Block 8, Peru

BakerRisk Project No.  
01-01943-013-19

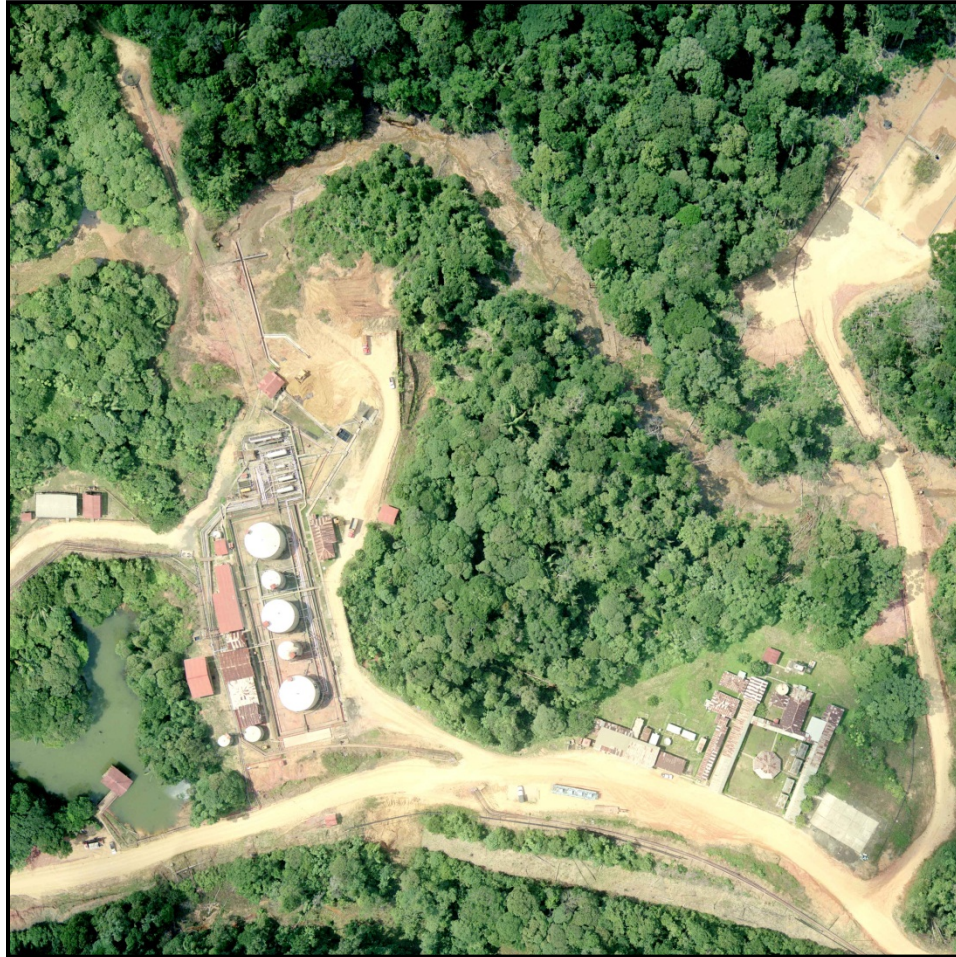
**Figure 15. Aerial Photo - Pavayacu Battery 9**

The Pavayacu batteries are installed on elevated sites of restricted size, and the plant layouts are more congested, as depicted in Figure 15.

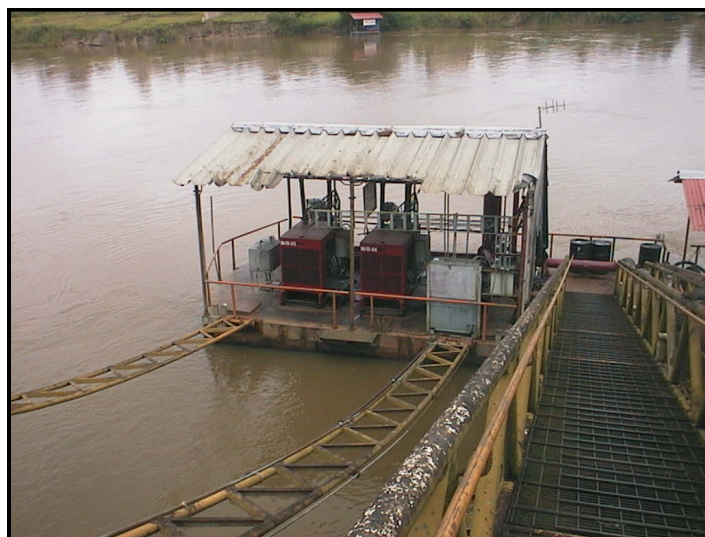
**Figure 25. Corrientes Battery 1 and 2 Fire Pumps**

At Corrientes, there are two diesel engine-driven fire pumps, each rated at 2,400 gpm at 150 psi that take suction from the Corrientes River as depicted in Figure 25, below. Fire pump data is included in Appendix M for the remaining Block 8 operations.

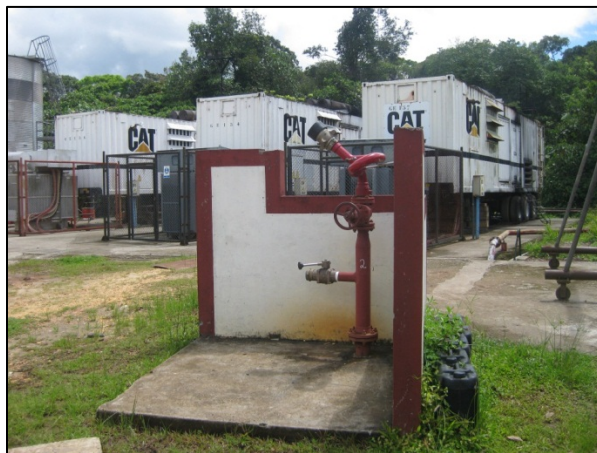
**Figure 26. Monitor Nozzle Protection (with a radiant heat shield) at the Pavayacu Electrical Plant**

There are an adequate number of hydrants and monitor nozzles installed in the process areas. Monitor nozzle protection is provided at some of the Electrical Plants, as shown in Figure 26, below, and is considered to be adequate.

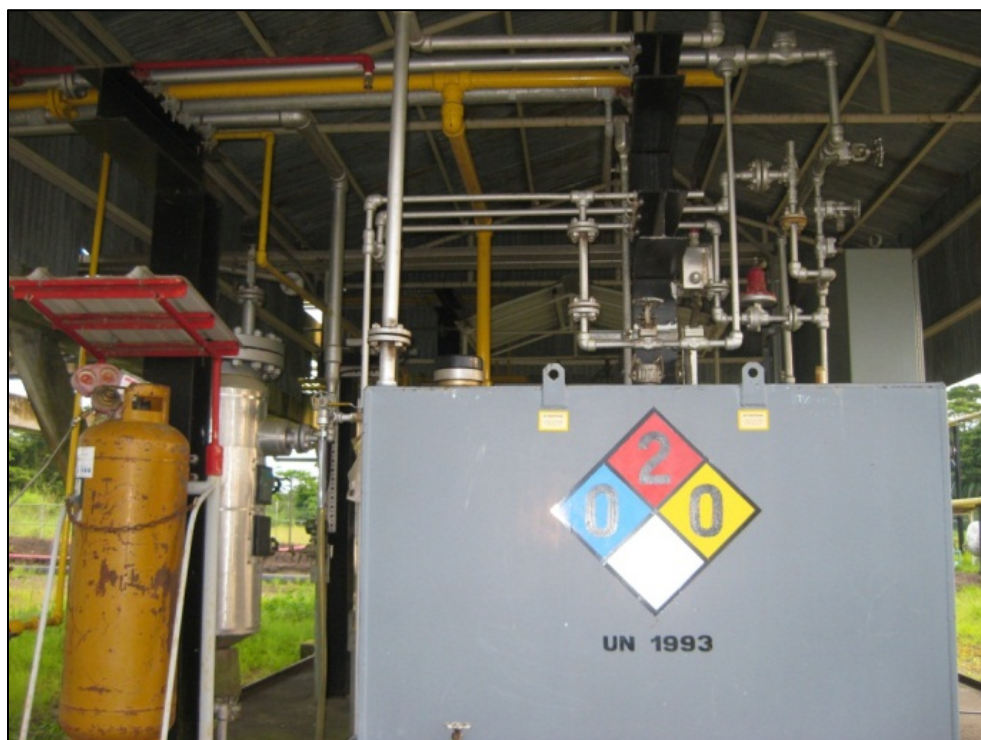
**Figure 27. Automatic Sprinkler Protection for Diesel Fuel Tank in Topping Unit**

An automatic sprinkler system is provided over Residue Oil Pumps Nos. P-1102 A/B, Product Pump Nos. P-1103 A/B, Diesel Column Reflux Pump Nos. P-1105 A/B, Crude Column T-1101 and Diesel Tank No. TK-1101 for the Topping Unit, as depicted in Figure 27 and Figure 28, on the following page. The system also covers the Crude Column up to 20 feet. The 24 sprinklers are supplied via a 3-inch connection controlled by an outside screw and yoke (O.S.&Y.) valve from the 10-inch water main. The sprinkler system for the pumps are designed to provide a density of 0.50 gpm over the entire surface area of the pumps and the sprinklers for the Diesel Tank, as well the columns are designed to provide a density of 0.30 gpm over the entire surface of the container or area.
